# Manhole Inspection Summary

Manhole # S29M\_\_059MH

Insp Date: **5/13/09 4:28 PM**

**Location** Address: **803 Scott St**

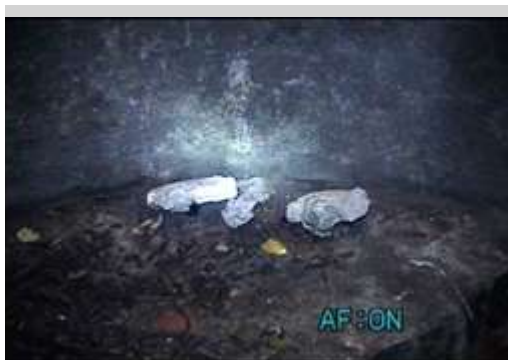
Miscellaneous

debris on bench

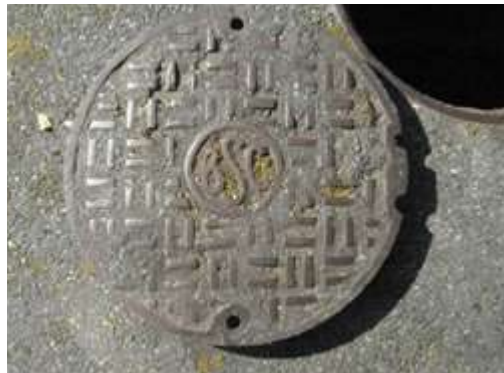
Miscellaneous

mh cover

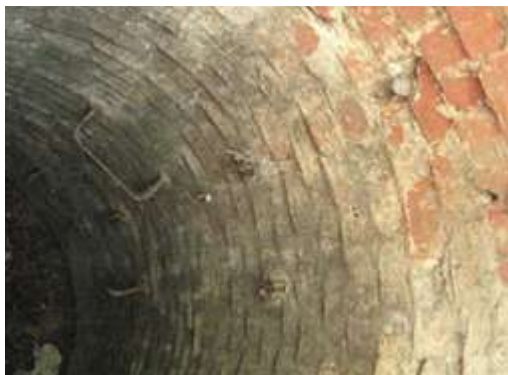
Defect 4

**Steps** Count: **6** Missing: **6** ☒ **Corroded**

Corroded & missing rungs

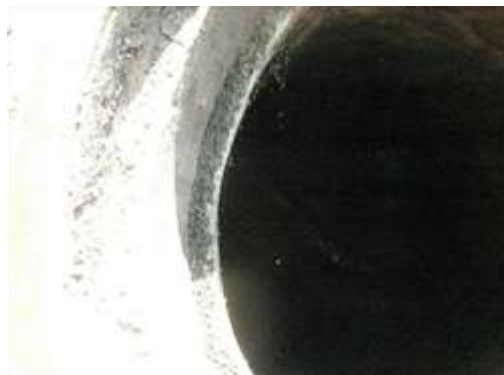
Defect 1

**Frame** Offset: **0.5** (in.) Condition: ☒ Sound ☐ Cracked ☐ Leaks

1/2 " frame offset

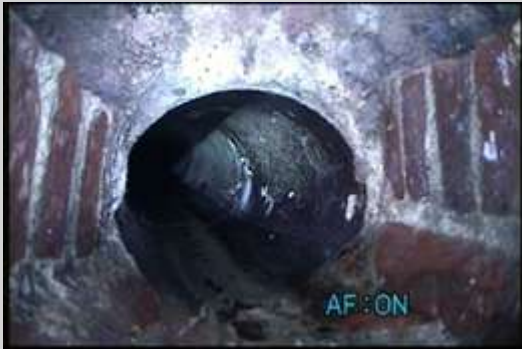
12 O'Clock Outflow

8 in. Circular Gravity Sewer  
Pipe Out @ 12 O'Clock

Pipe Height: **8.4** (in.) Rod and Bar (Angled)  
Pipe Material: **Clay** ☐ Pipe Lined  
Invert Depth: **9.96** (ft.) Flow Characteristics: **Fast**  
Deposits: ☒ None ☐ Mud ☐ Sludge ☐ Debris ☐ Grease  
Silt Depth: **0** (in.) Deposits Extent:  
Infiltration: **None** Pipe Seal Cond: **Sound**

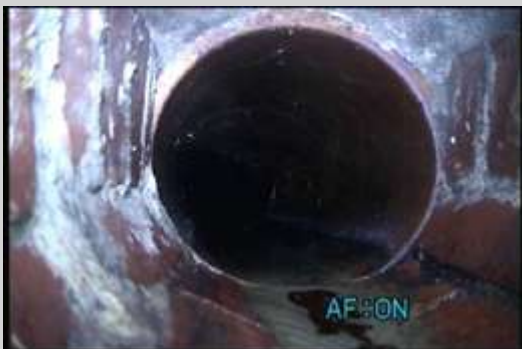
7 O'Clock Inflow

8 in. Circular Gravity Sewer  
Pipe In @ 7 O'Clock

Pipe Height: **7.2** (in.) Rod and Bar (Angled)  
Pipe Material: **Clay** ☐ Pipe Lined  
Invert Depth: **9.56** (ft.) Flow Characteristics: **Fast**  
Deposits: ☒ None ☐ Mud ☐ Sludge ☐ Debris ☐ Grease  
Silt Depth: **0** (in.) Deposits Extent:  
Infiltration: **None** Pipe Seal Cond: **Sound**
